## Feasibility of using bamboo as a potential reinforcement in concrete beams

Athauda, A.M.B.B.S., Wijebandara, M.M.A., Ihalakodippily, I.K.K.G. and Wanniarachchi, K.S.

*Department of Civil and Environmental Engineering, Faculty of Engineering, University of Ruhuna, Hapugala, Galle, Sri Lanka*

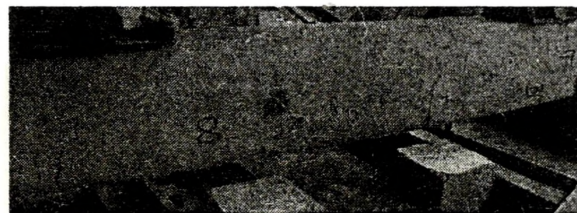
**Figure 8: Cracks pattern for 2.6% yellow bamboo reinforcement beam**

The second beam was tested with 4.5 a/d ratio and 2.6% of reinforcement area and the loading point was set at 641 mm from each end. First crack due to bending was appeared at 11.28kN load and final failure load was 25.99kN. All the cracks are shown in the Figure 8.

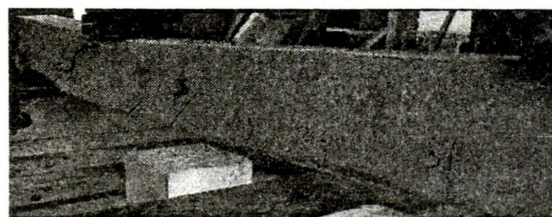
**Figure 9: Bamboo reinforcement beam with 1.5% of green bamboo**

The third test was conducted for green bamboo reinforced beam with 4.5 a/d ratio, and 1.5% reinforcement and loading point was set at 760 mm from each end. The first crack was initiated at 7.484 kN load and the failure load was 14.7 kN. The crack pattern is shown in Figure 9 and failure pattern was identified as shear failure.

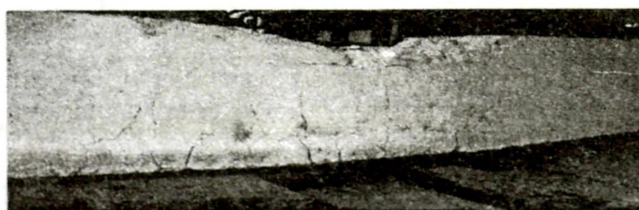
**Figure 12:** Cracks locations of 1% of bamboo + 1% of steel with steel stirrups

In this test used 1% of steel and 1% of bamboo r/f used and test was done and check the failure mechanism and compare the failure behavior of 1% steel used beam. The first crack of combination of bamboo and steel was at 38.259kN and failed at 64.25kN. For 1% of steel r/f beam initial crack was occurred at 39.73kN and failure load was at 58.86kN. According to the crack pattern there was no any shear failure occurred within the beam. Cracks pattern most probably was same for both beams as shown Figure 12.

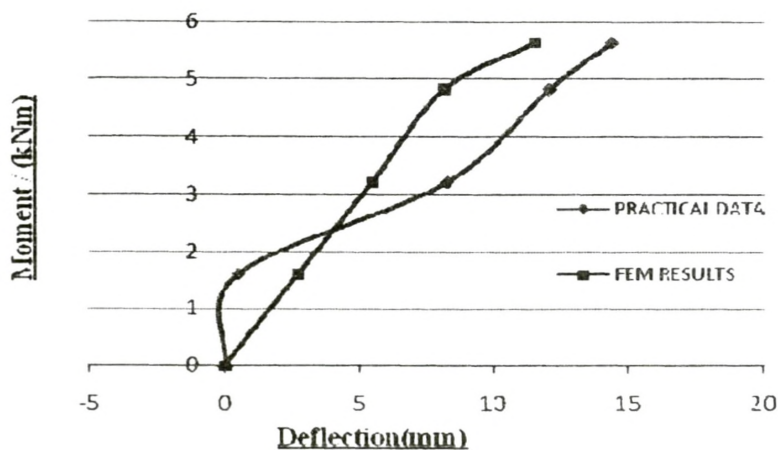
Graph 08: Comparison of moment vs. deflection for bamboo 1.5%

According to graph 08, 09 it can be seen that moment-deflection values obtained from experimental program are closely match the value obtain from the FEM model. So with FEM can achieve the moment vs. deflection values for different bamboo percentages.
